**BEA**  
Bureau d'Enquêtes et d'Analyses  
pour la sécurité de l'aviation civile

Objet : FDR Preliminary Sequence of Events

V/réf : 30/05/2008 A320 EI-TAF TACA accident in Tegucigalpa Airport

### Preliminary sequence of events from DFDR

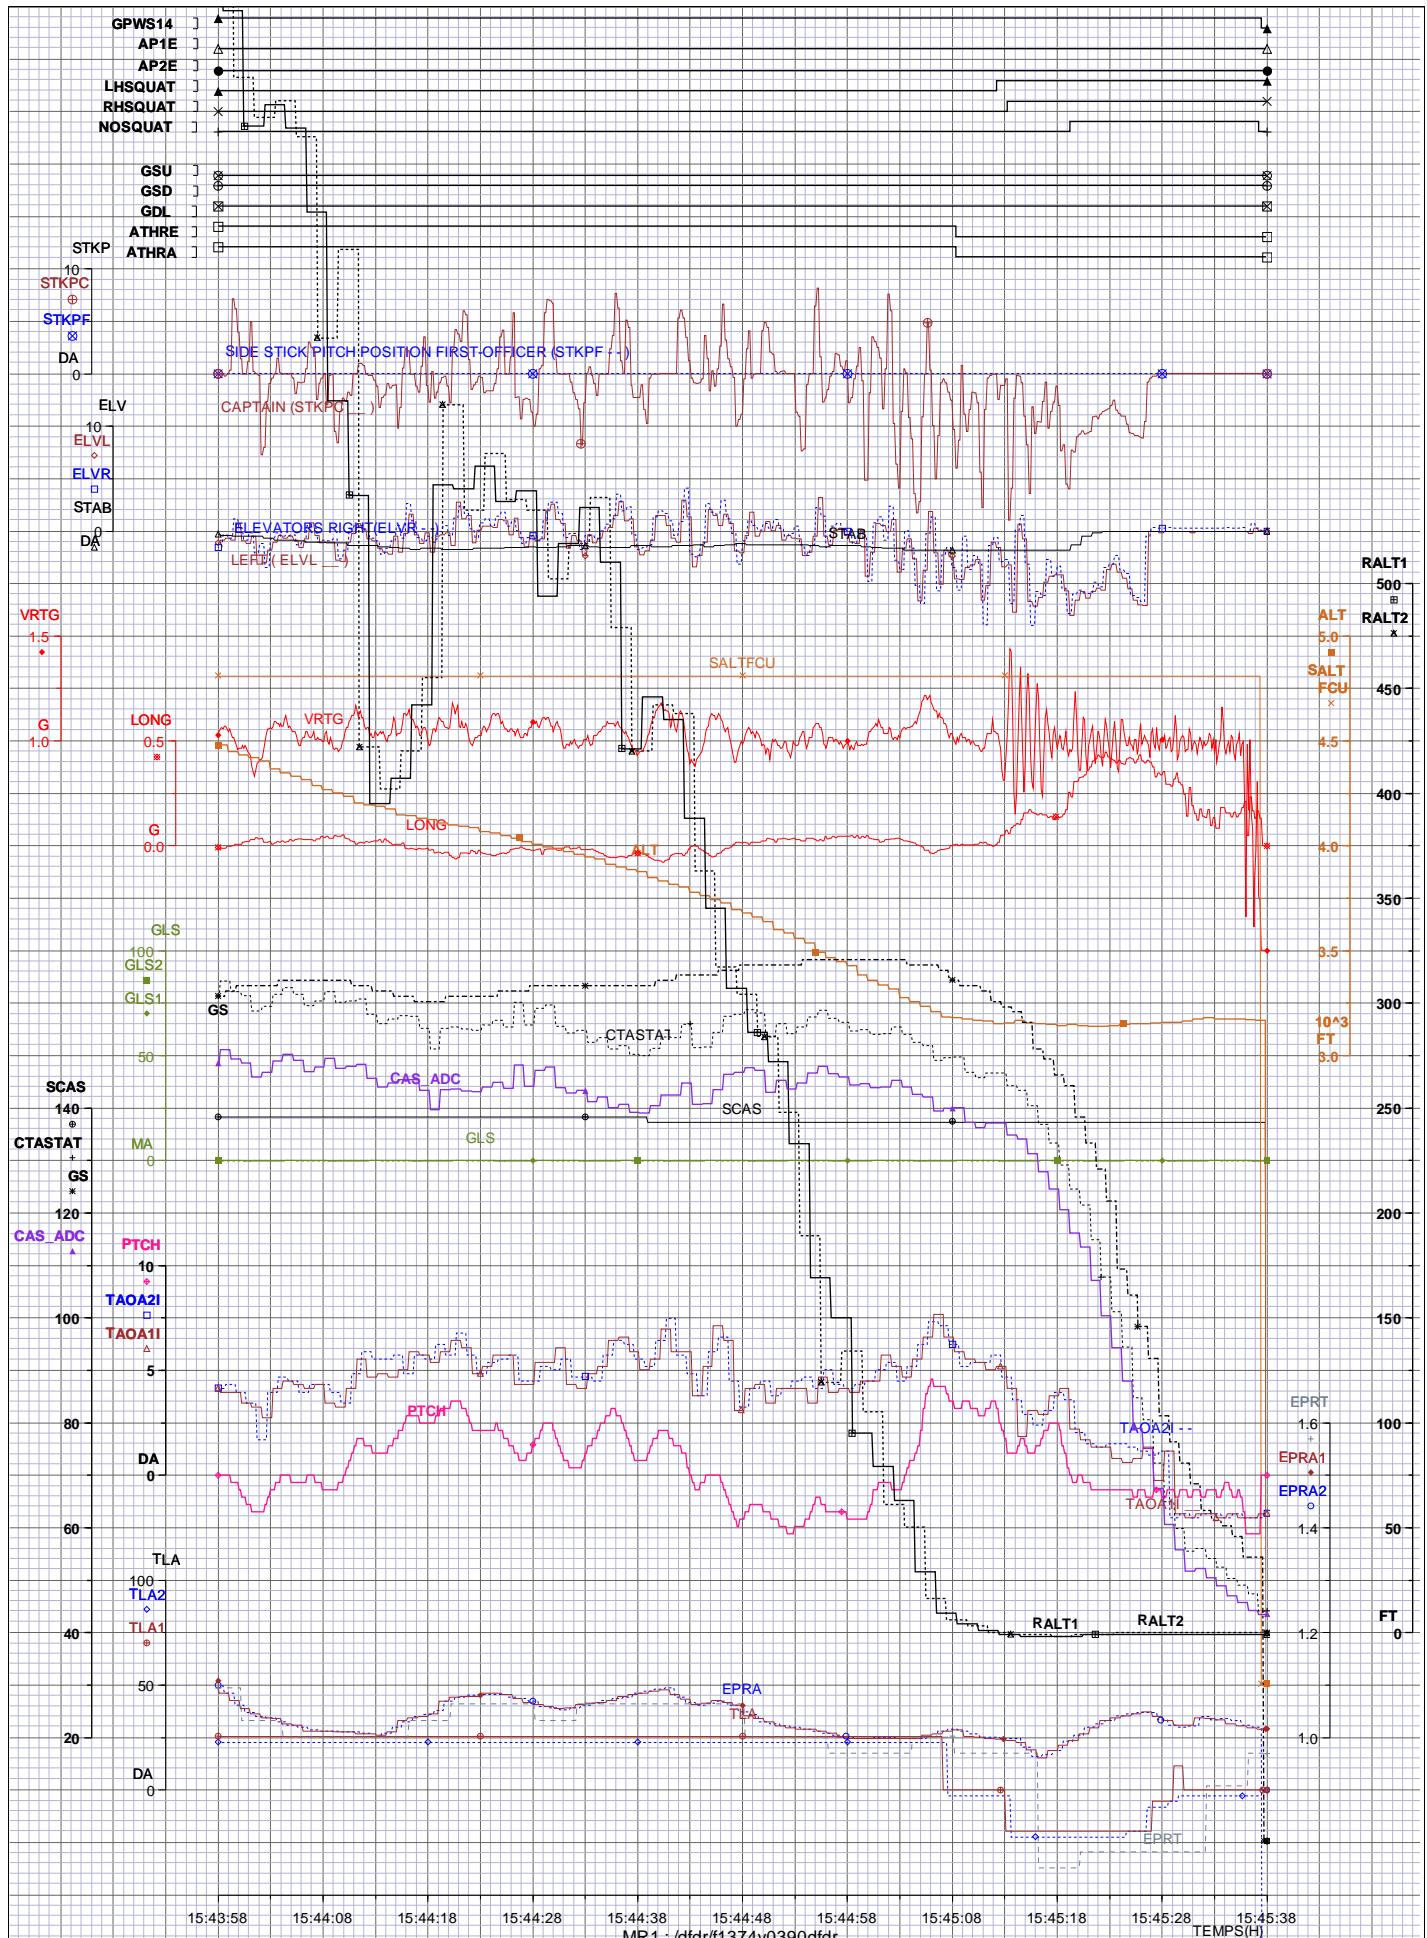
1.1

Approach performed with auto-pilots and flight-directors OFF, auto-thrust ON. Auto-brake MED was selected. After the final turn to runway 02, there was an approximately 10kt tailwind.

At flare initiation, approximately 50ft:  
CAS=145kt, TAS=155kt, GS=168kt.

## APPROACH (LONGITUDINAL)

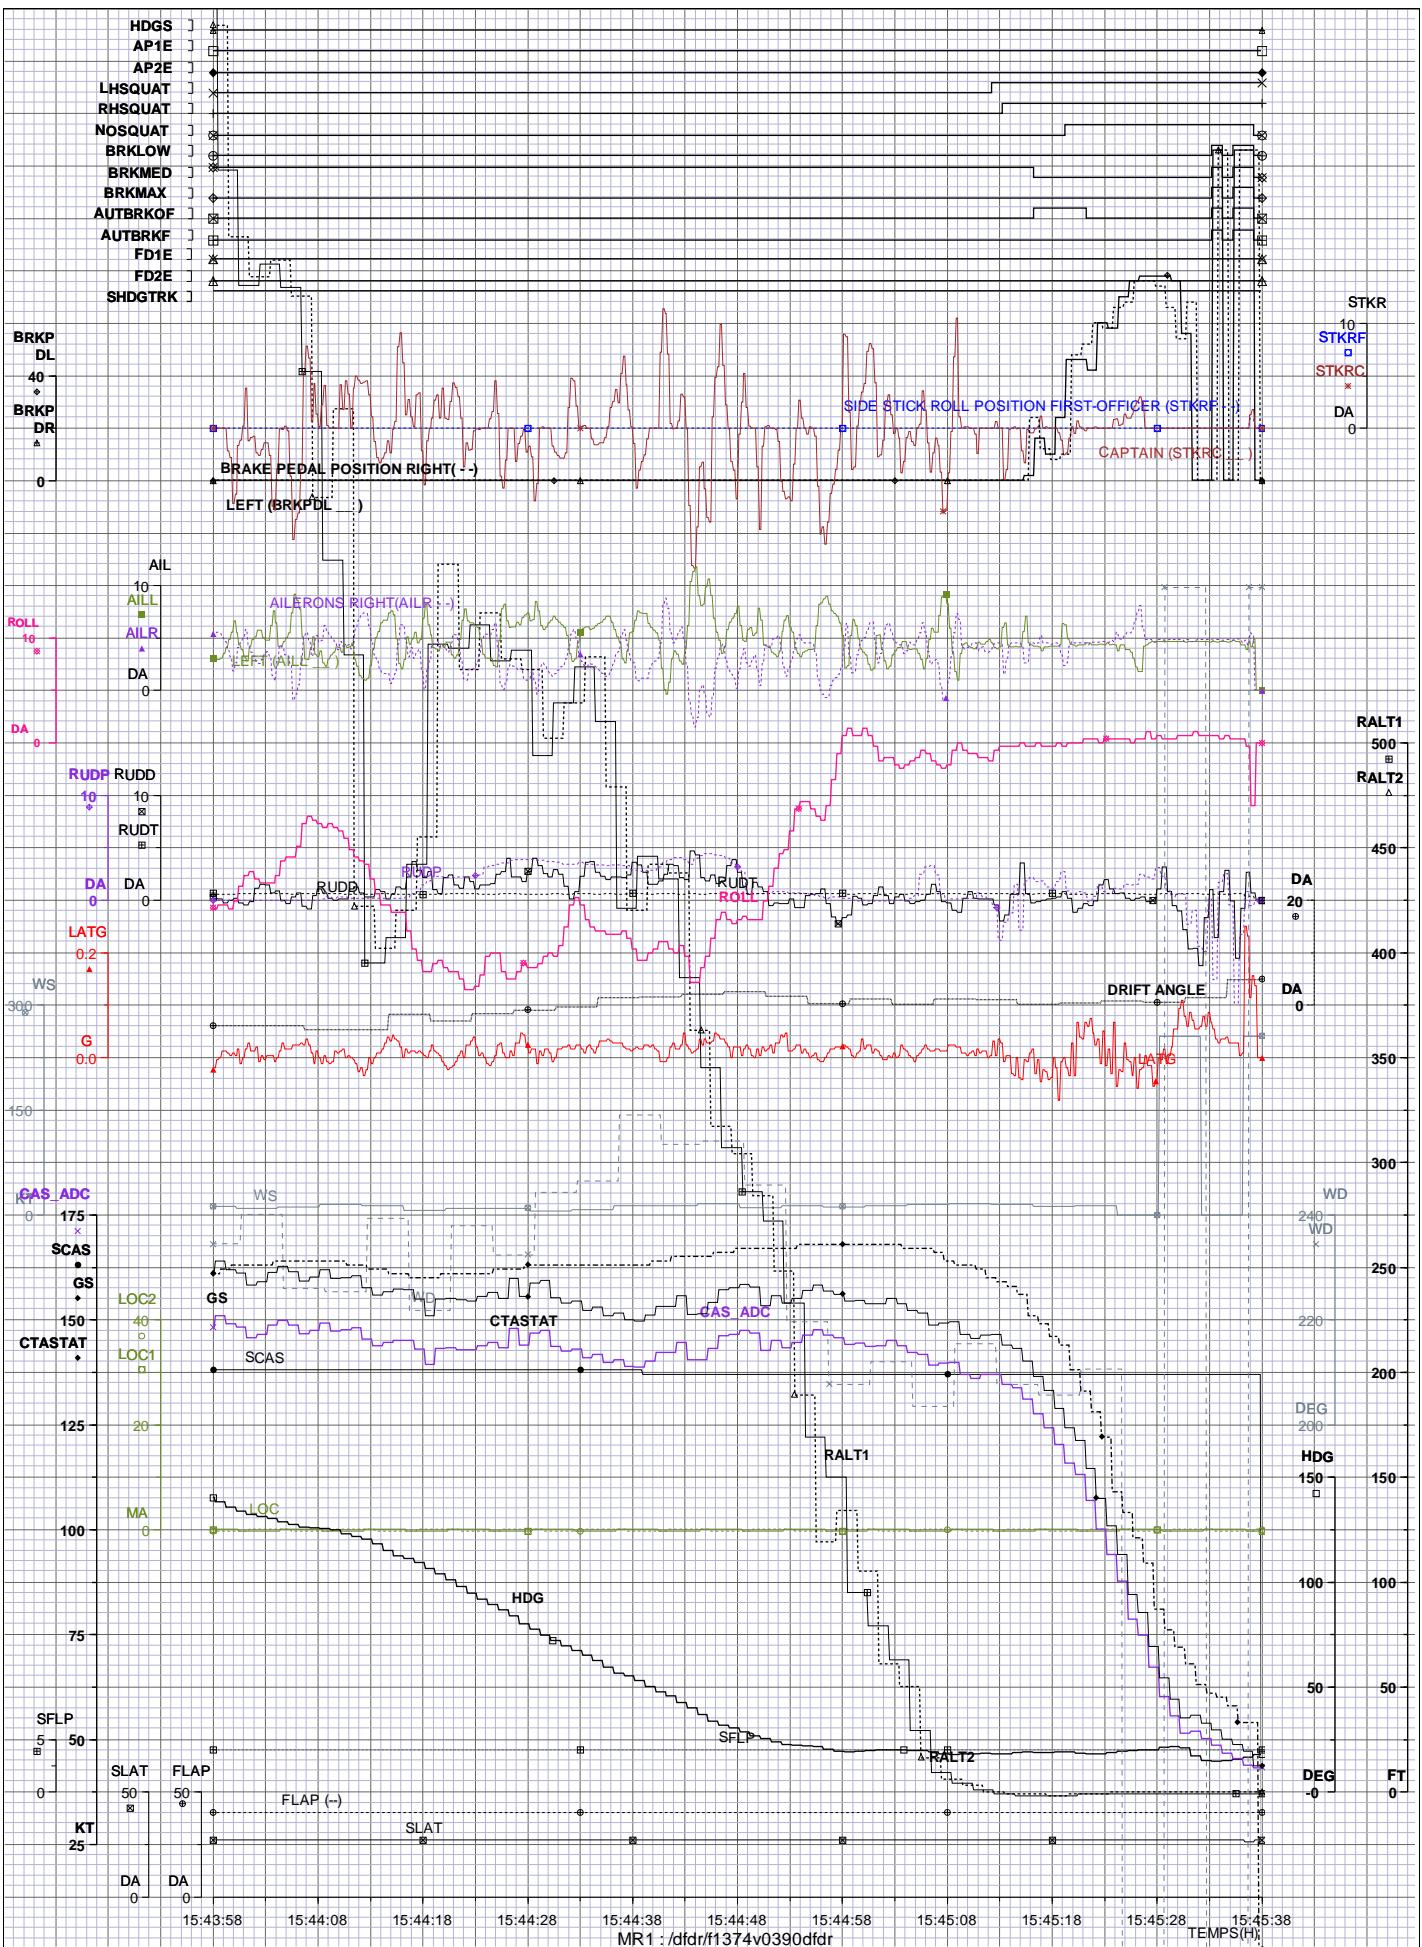
## **APPROACH (LATERAL AXIS)**

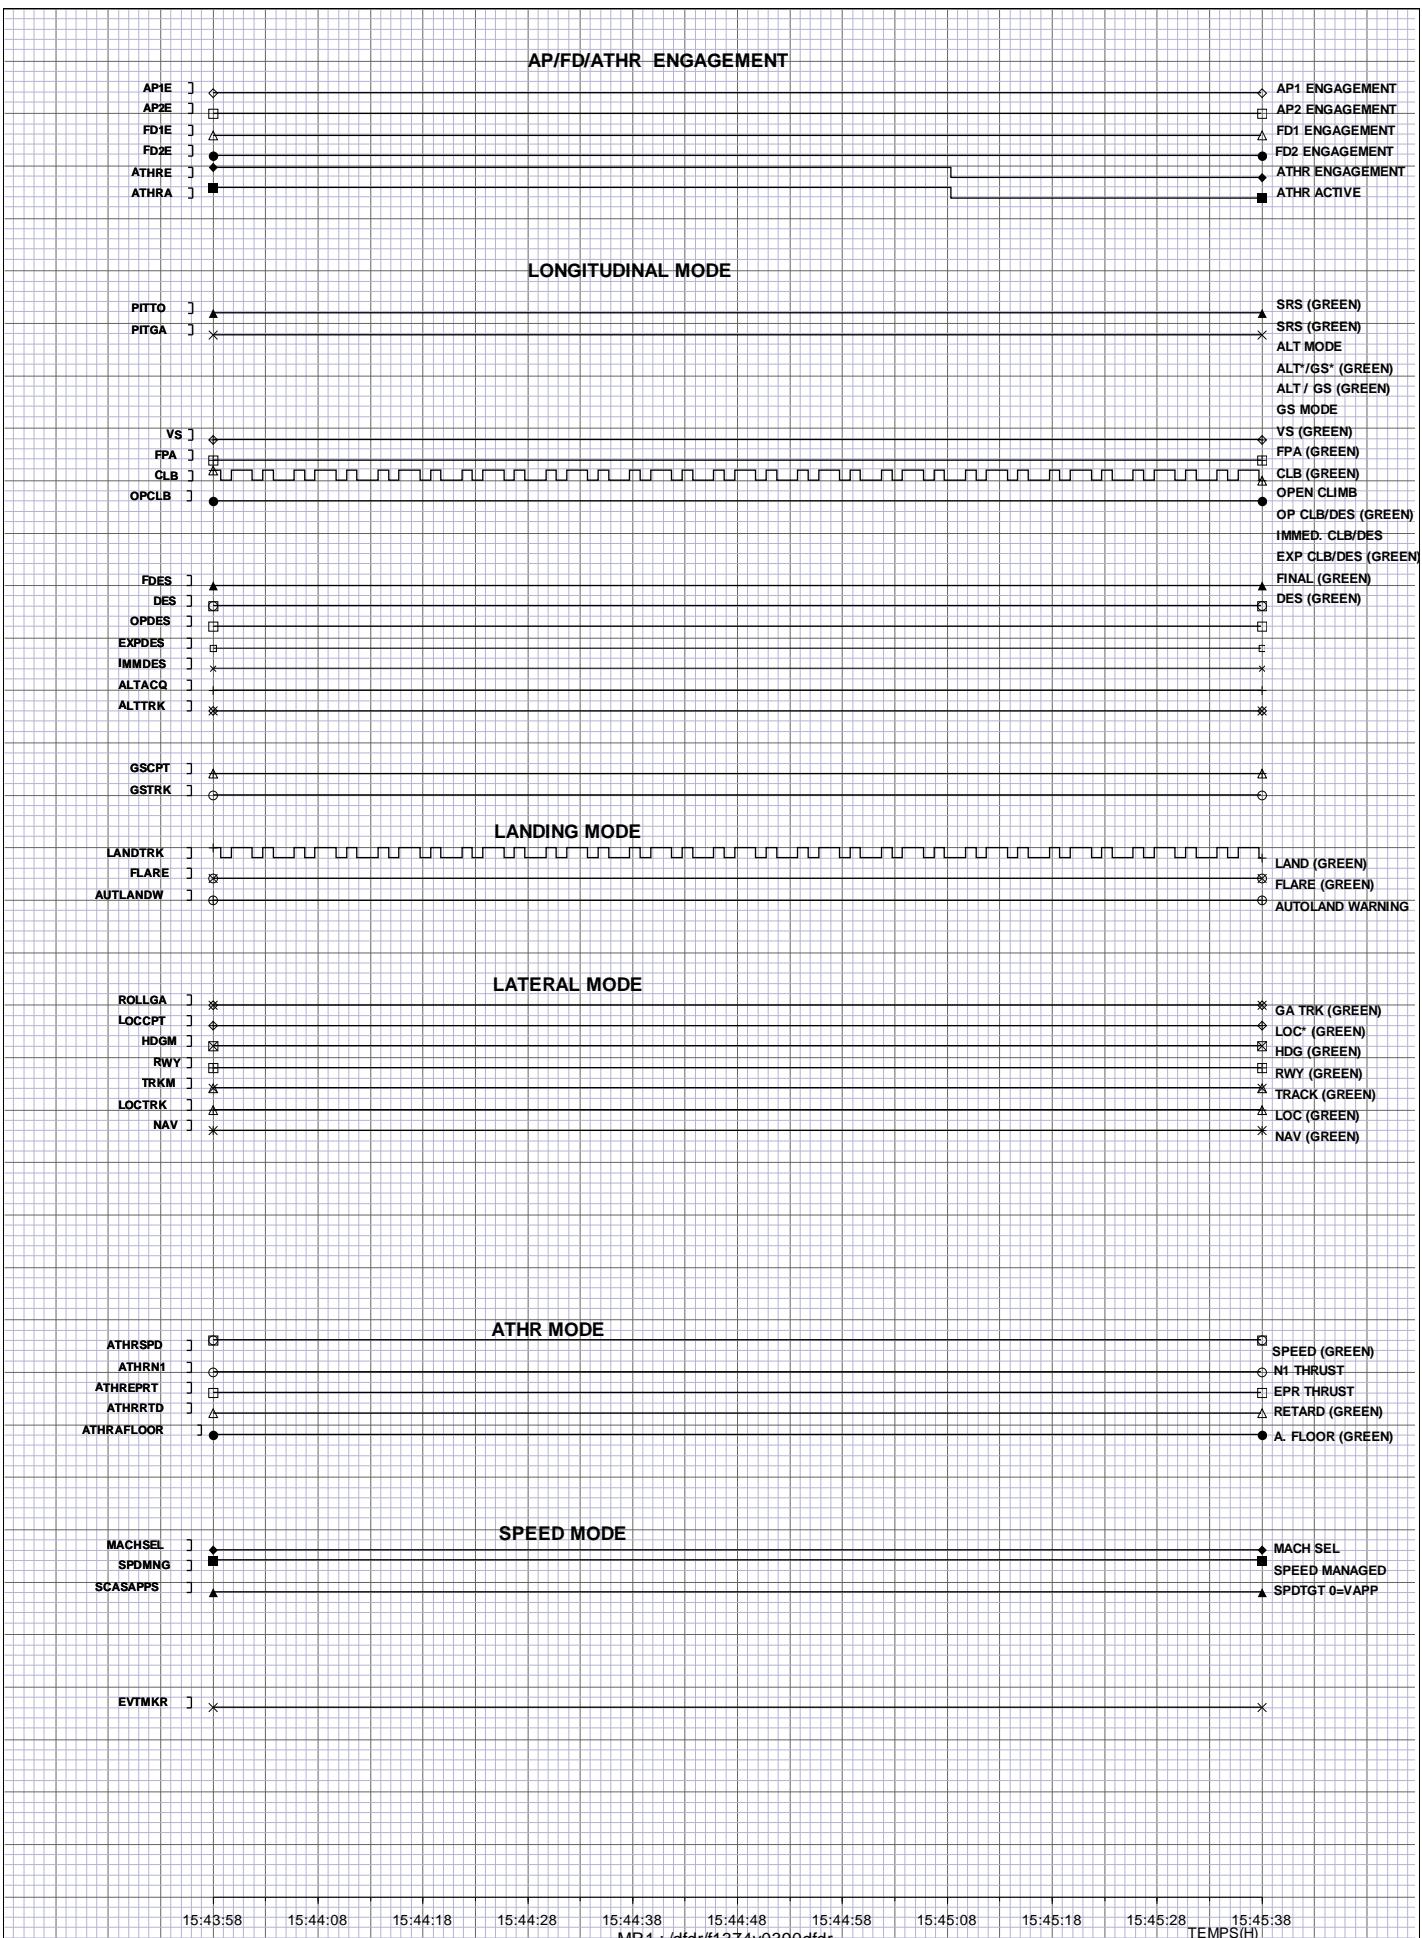
## **SA A/P MODES**

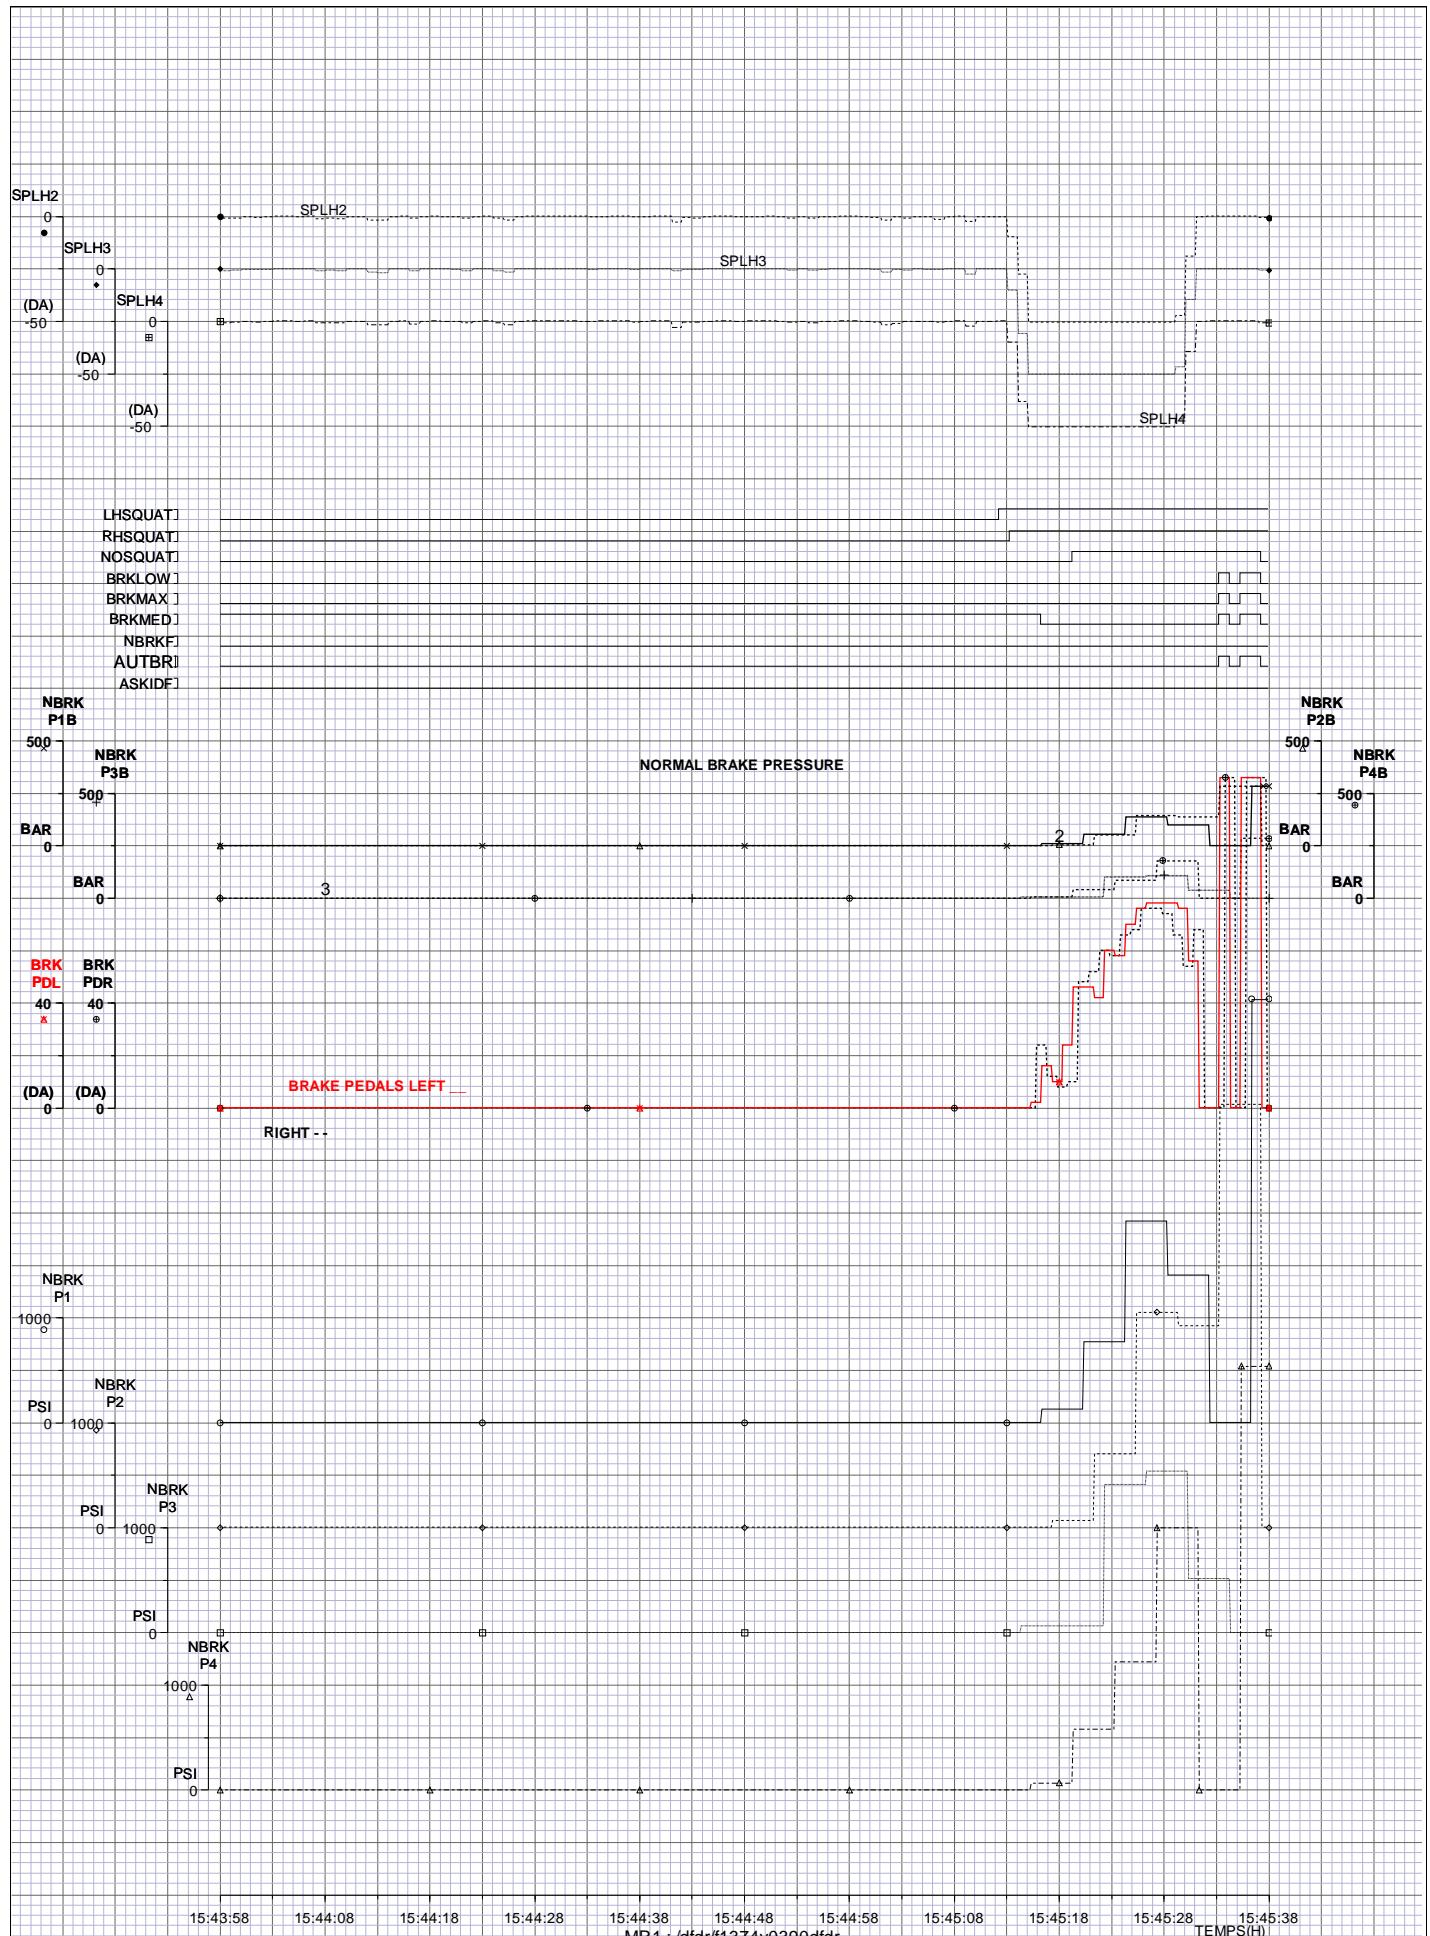
Figure 1.4

T0+4s: Start of manual braking action, leading to A/BRK disengagement.

- Remark: A/BRK normally starts to apply brake pressure 4 sec after spoilers' deployment. Manual braking action prevented A/BRK activation in this case.

T0+7s: Nose gear compressed. Brake pedals were progressively applied up to maximum (80°). Some aft stick was maintained during 8sec after nose landing gear touch down.

WGT (LBS) 140120.00  
EXCURSION WGT (KG)= 63558.31**BRAKE PRESSURES**

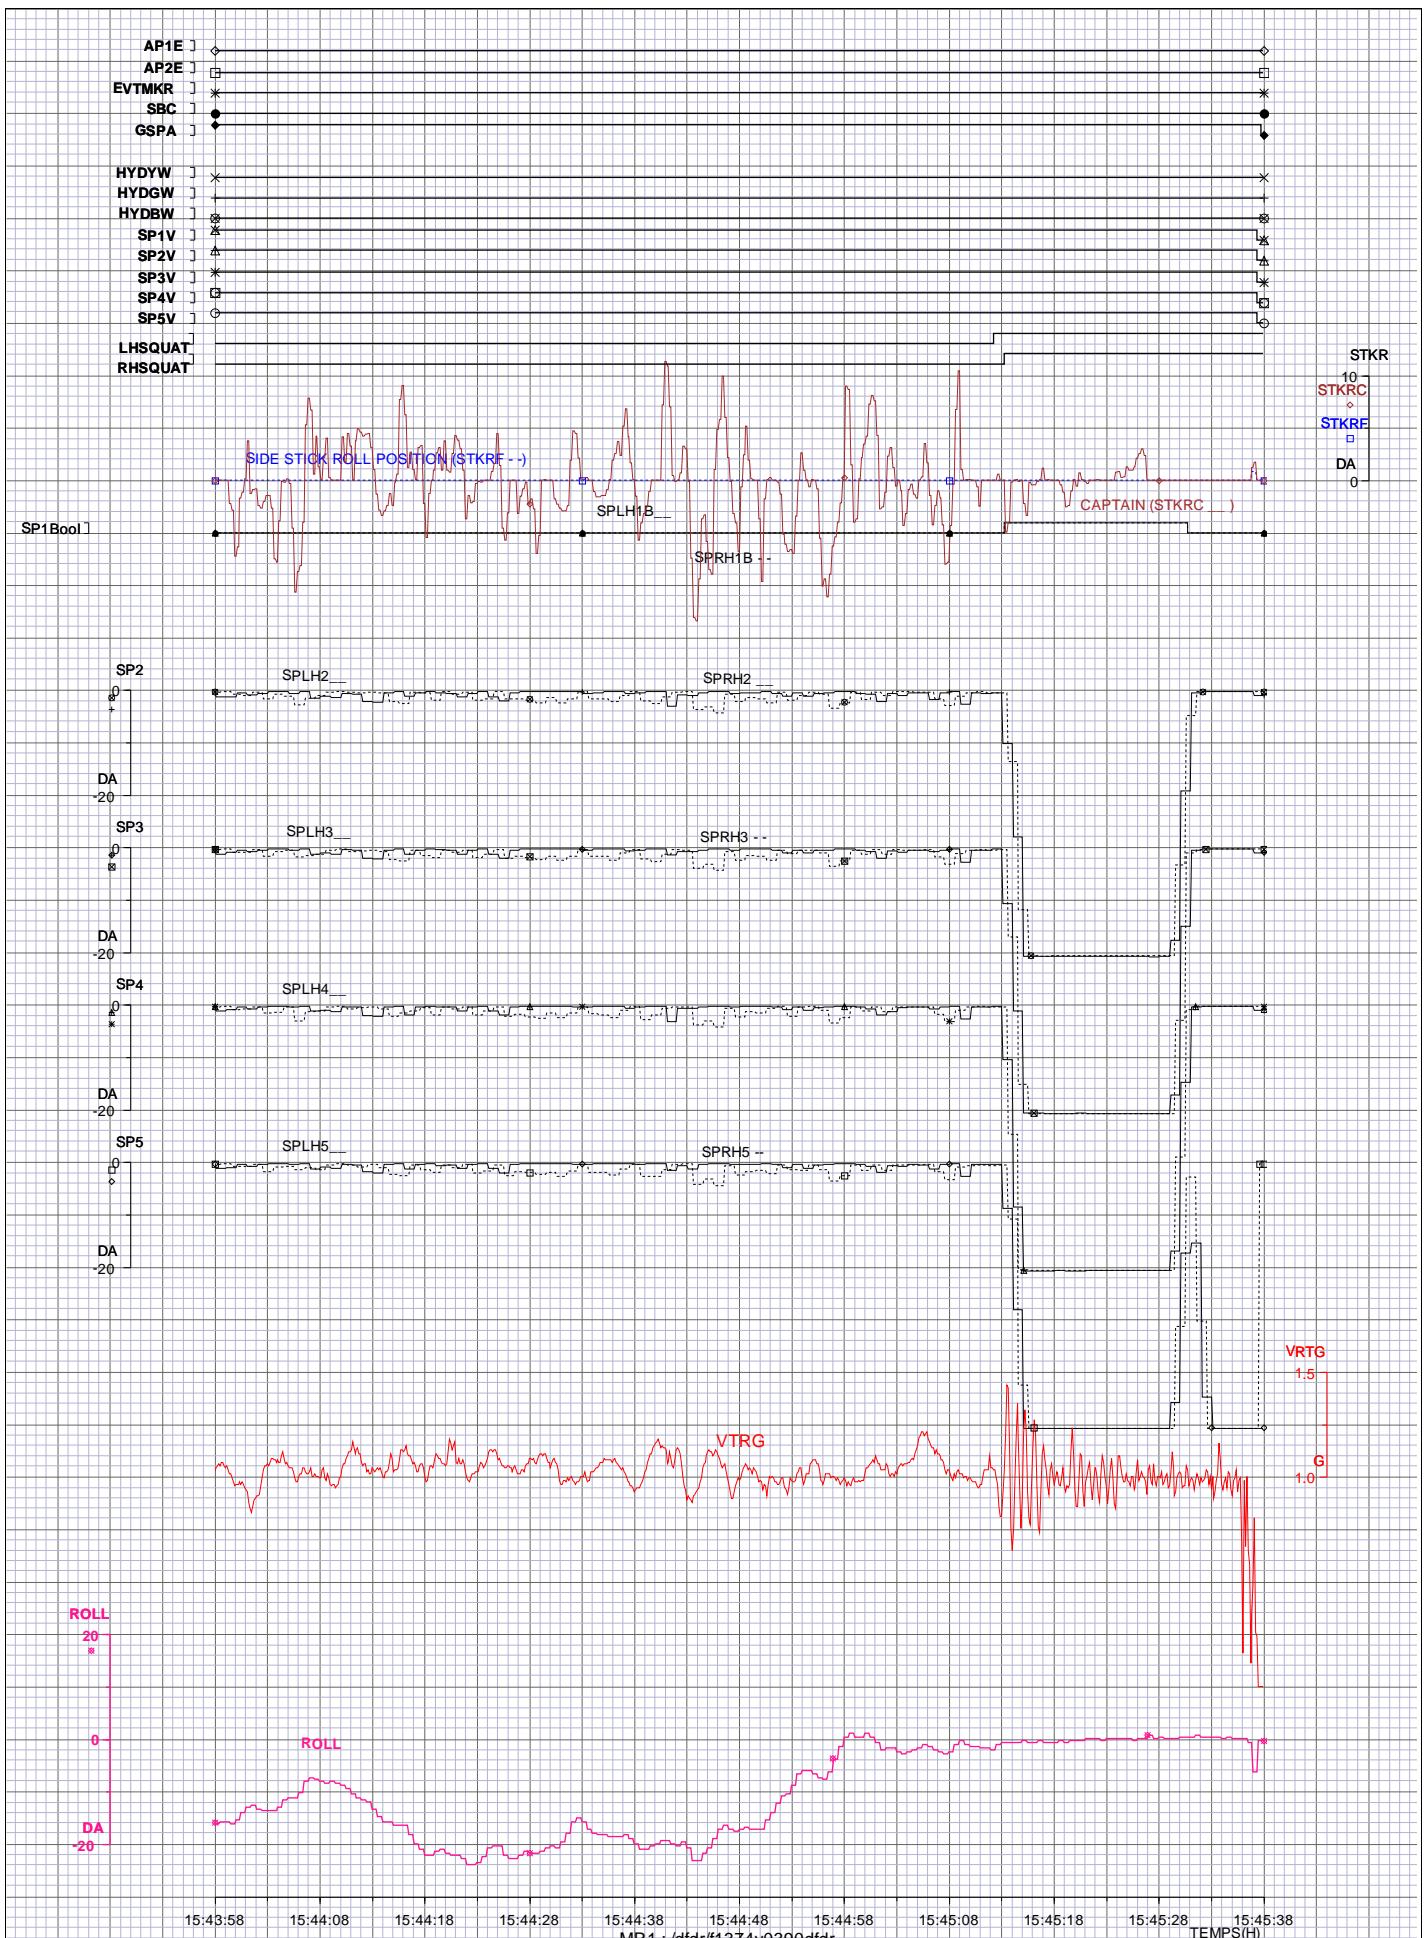
Figure 1.5

T0+1s: Spoilers started to deploy. Max reverse selection.

T0+17s: Thrust levers were advanced to forward idle. Thrust lever 1 was transitorily advanced to a recorded position of 10°. The ground spoilers started to retract (Indicating that the thrust lever #1 reached probably 20°, even if not recorded due to sampling rate). Ground speed was approximately 72kt at this time. Then spoilers 5 deployed again while spoilers 1 to 4 remained stowed. This was probably due to the following:

- Ground spoilers logic:
  - o SEC#1 commands spoilers#3 & #4, SEC#2 commands spoilers#5, SEC#3 commands spoilers#1 & #2.
  - o The ground spoilers logic leads to spoilers extension if thrust levers are at idle and (there is a transition to gear compressed or wheel speed is above 72kt).
- When the thrust lever#1 was advanced, all spoilers retracted. When it was retarded again, the wheel speed was approximately 72kt. The wheel speed acquired by the SEC#2 was probably just above 72kt, leading to spoilers #5 re-deployment. At this time, the wheel speed acquired by the SEC#1 & #3 was probably just below 72kt, preventing Spoilers#1 to #4 re-deployment.

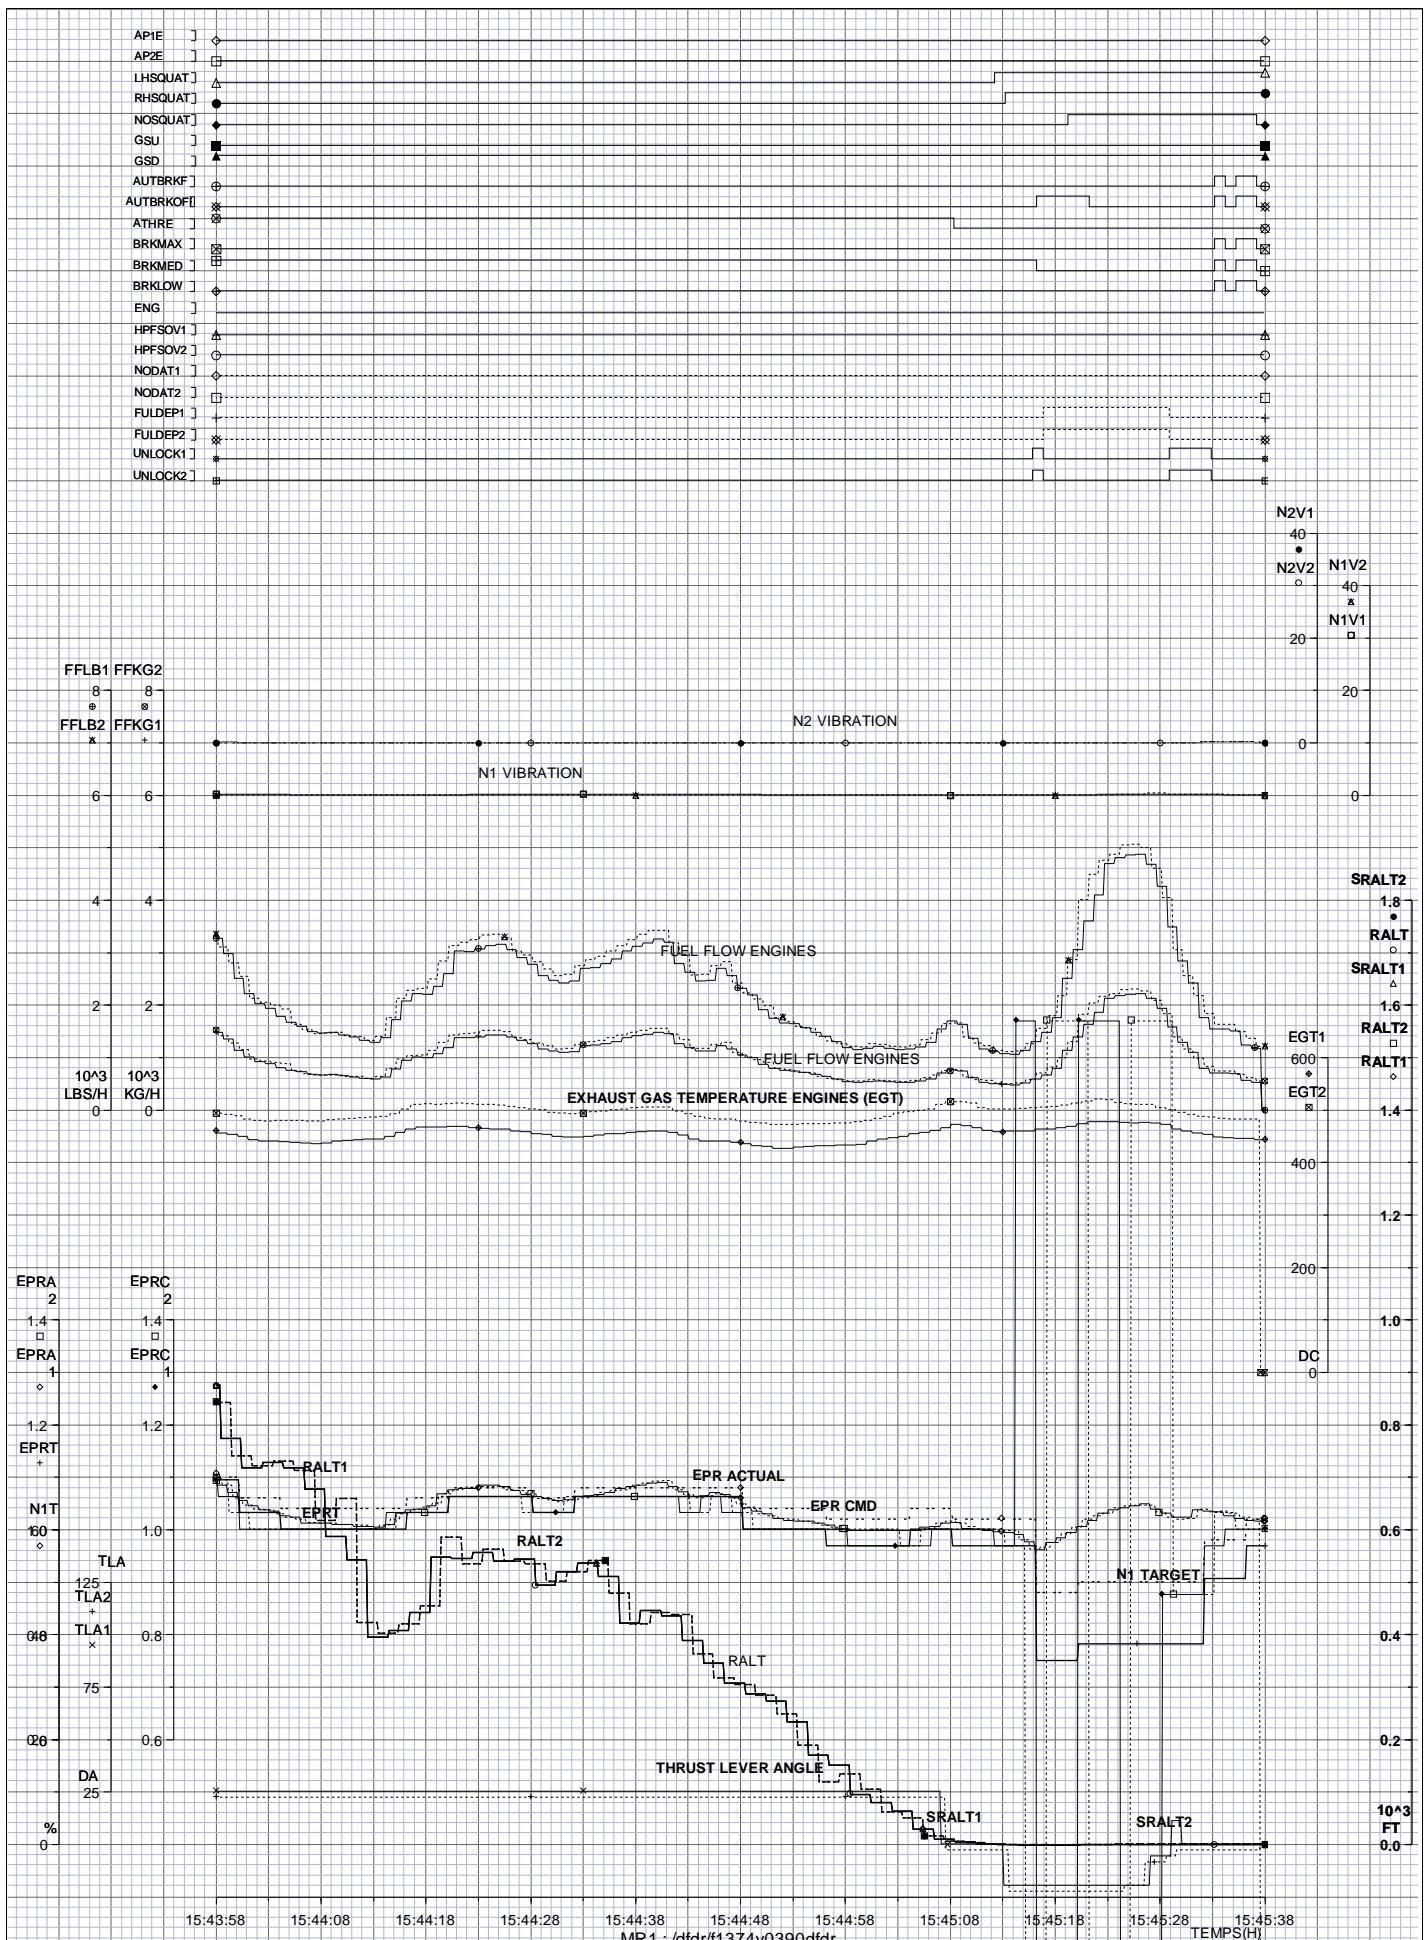
Figure 1.6

The thrust levers were retarded at approximately 5ft, 5sec before touch down.

T0+15sec: Thrust levers were advanced from full reverse to idle reverse. There was no more aft stick. The deceleration started to decrease from approximately 0.35g to approximately 0.15g.

## ENGINE AND BRAKES BEHAVIOR

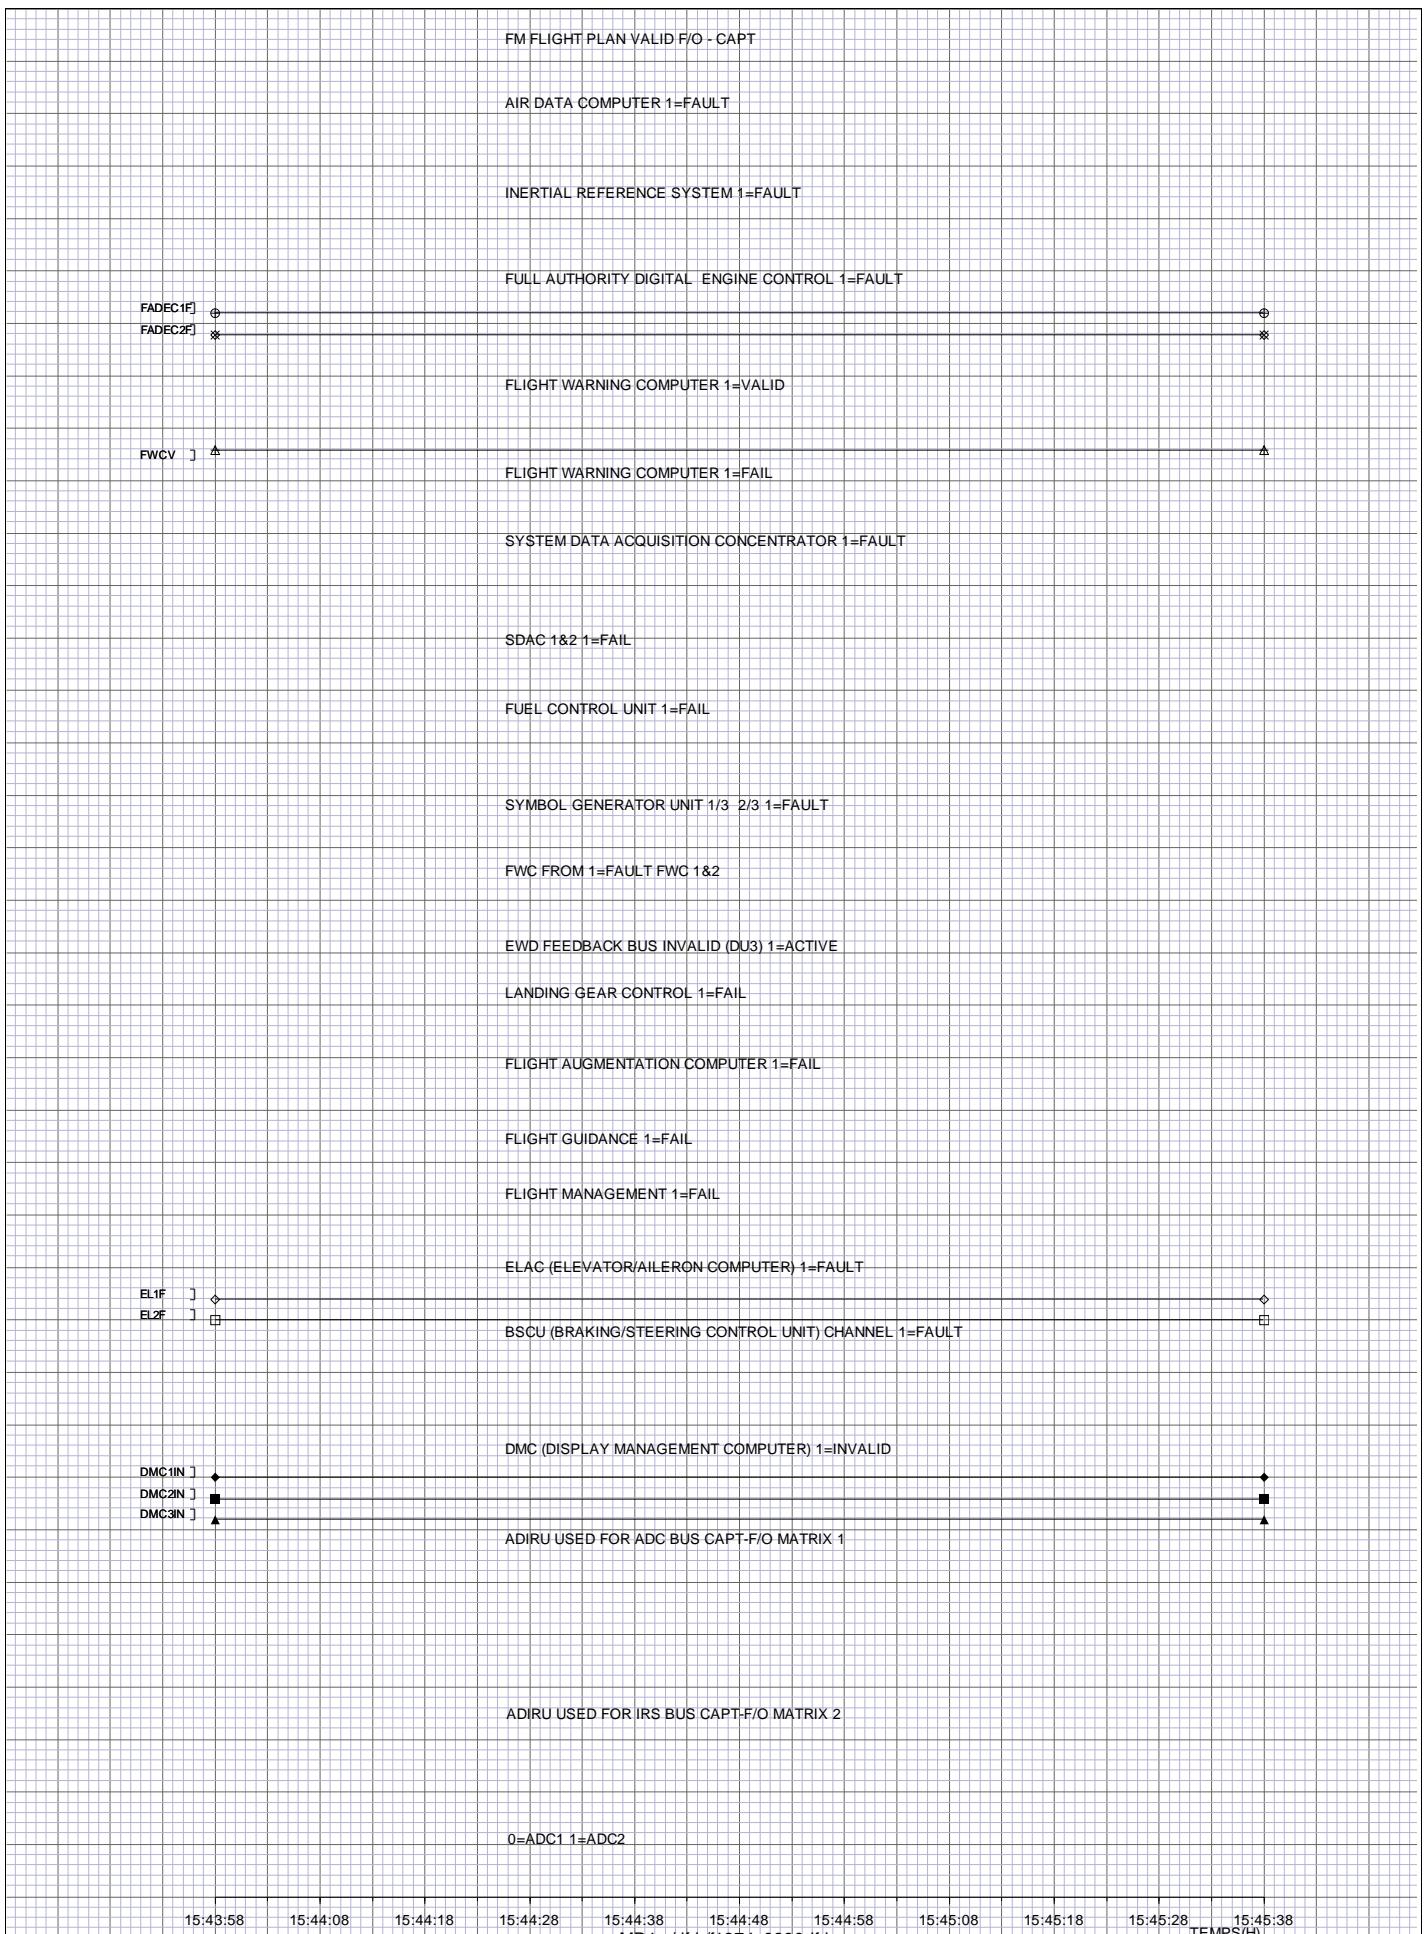
T0+19s: ASKIDON changed from 1 to 0. This was most probably due to the fact that the “A/SKID & N/W STRG” switch was manually selected to OFF.

- The ASKIDON comes from the SDAC and corresponds to the switch position. The ASKIDF, coming from the FWC, was at 0, showing that there was no antiskid failure detected by the BSCU. All parameters from BSCU were no more recorded correctly by the DFDR, which is the case when the “A/SKID & N/W STRG” switch is on OFF.

<b>Integration Test Centre</b>
<b>VALIDITY COMPUTERS AND CONFIGURATION</b>			
WGT(LBS) 140120.00 WGT(KG) 63558.31			Edited : 4/6/2008 Figure 1.7
/workgroup/operation/dfdr/visage/guillaume/F1374-RunwayExcursion/Computers-ValidityConfig.ilv

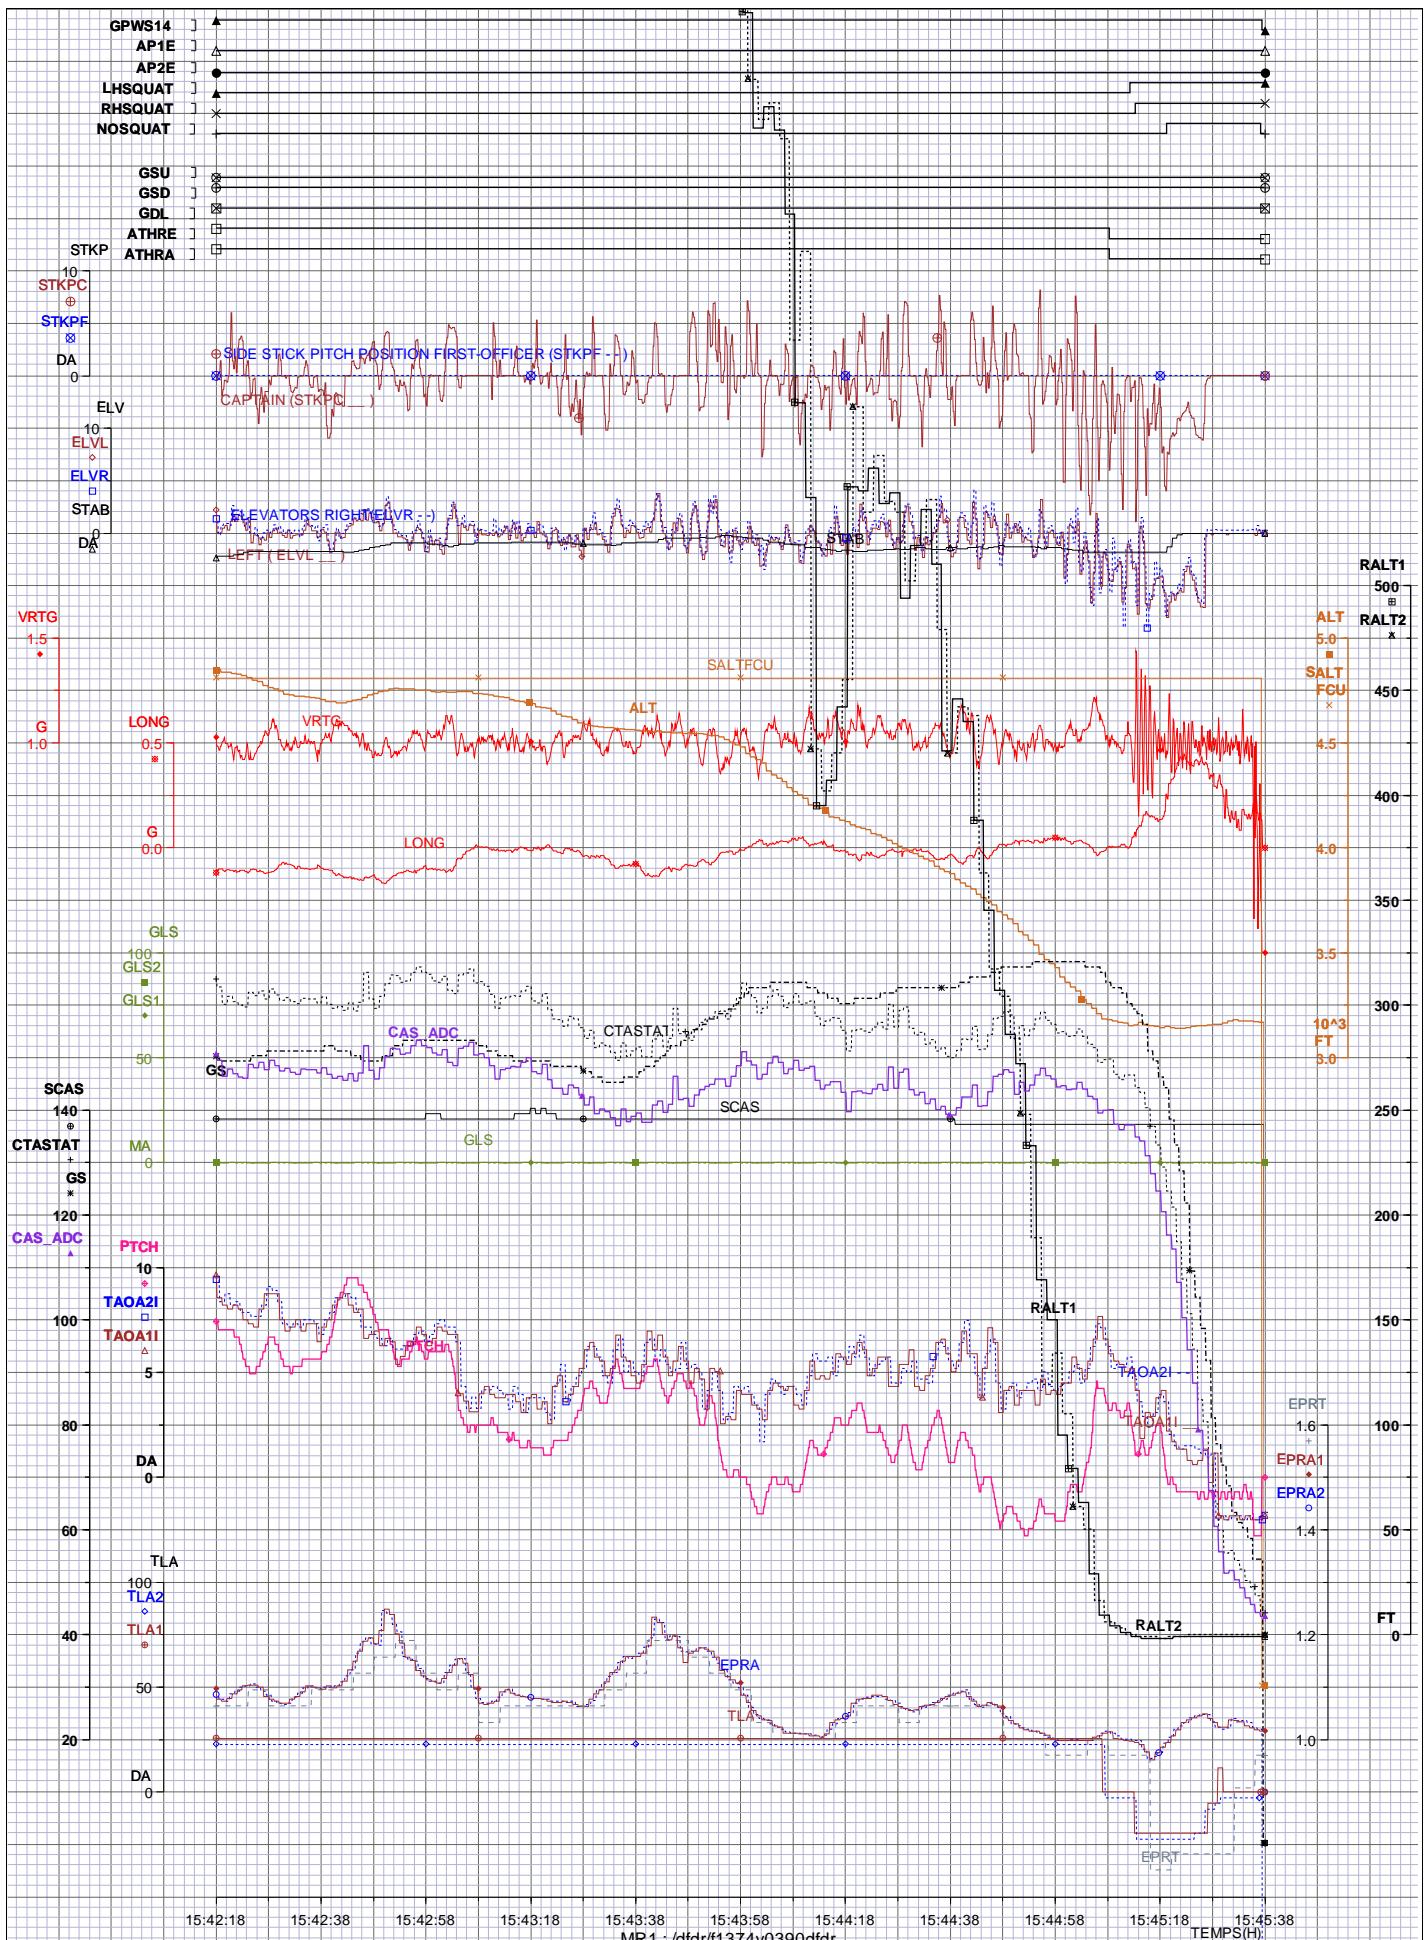
**Integration  
Test  
Centre**  
Edited : 4/6/2008  
Figure 2.1

## APPROACH (LONGITUDINAL)
